Manufacturing of PIP-II high power couplers - Experience feedback

S. Kazakov / FNAL

PIP-II Technical Workshop

December 2, 2020

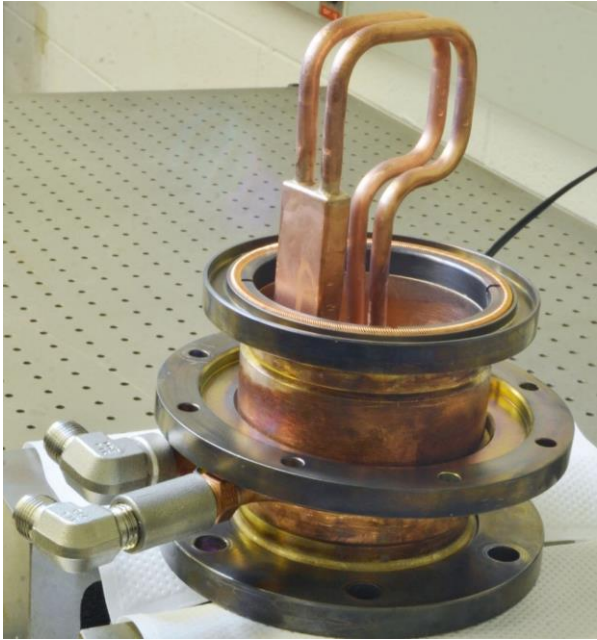
Two couplers and 4 RF windows produced by "Mega Inc." Mega is very good company for producing air filling waveguide systems. But Mega had no previous experience to braze RF windows. Finally they produced 4 windows with antenna with big delay. One window had a small leak but was accepted and installed to RFQ because of big delay.

Ceramics window unit.

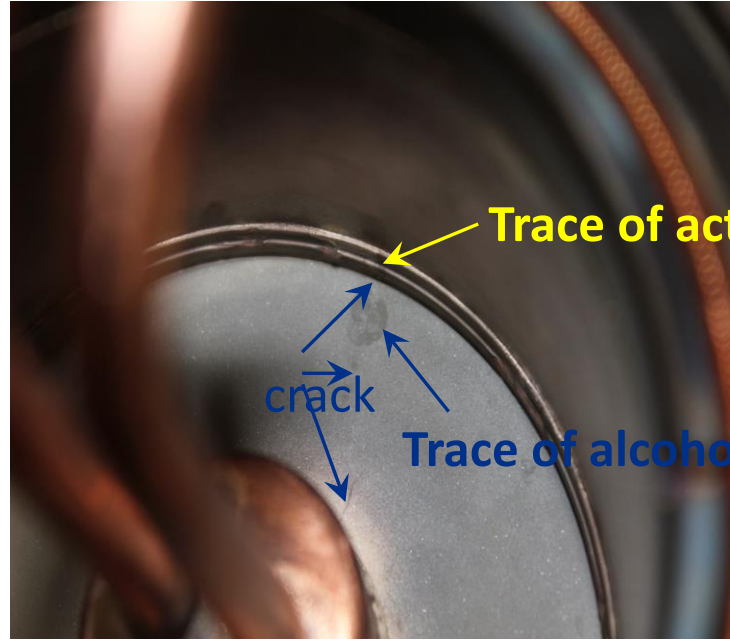
Broken ceramics.

After some operation at 65 kW, CW two window were broken. Reasons are not clear enough. Probably the quality of fabrication was not good enough. Another possible reason is overstressed window at the beginning of operation: by mistake air rate was 3 time less then necessary.

Ceramics was coted with TiN, 20nm. Coating was made by subcontractor of “Mega”. We could not check quality of coating and thickness.

During operation, before brake, ceramics become conductive, it was impossible to apply bias. Conductivity disappeared after window opening to air. Ceramic change color: initial color was light yellow, after operation – gray. Was this transformation of TiN?

Finally, we decided to design new window with replaceable ceramics.

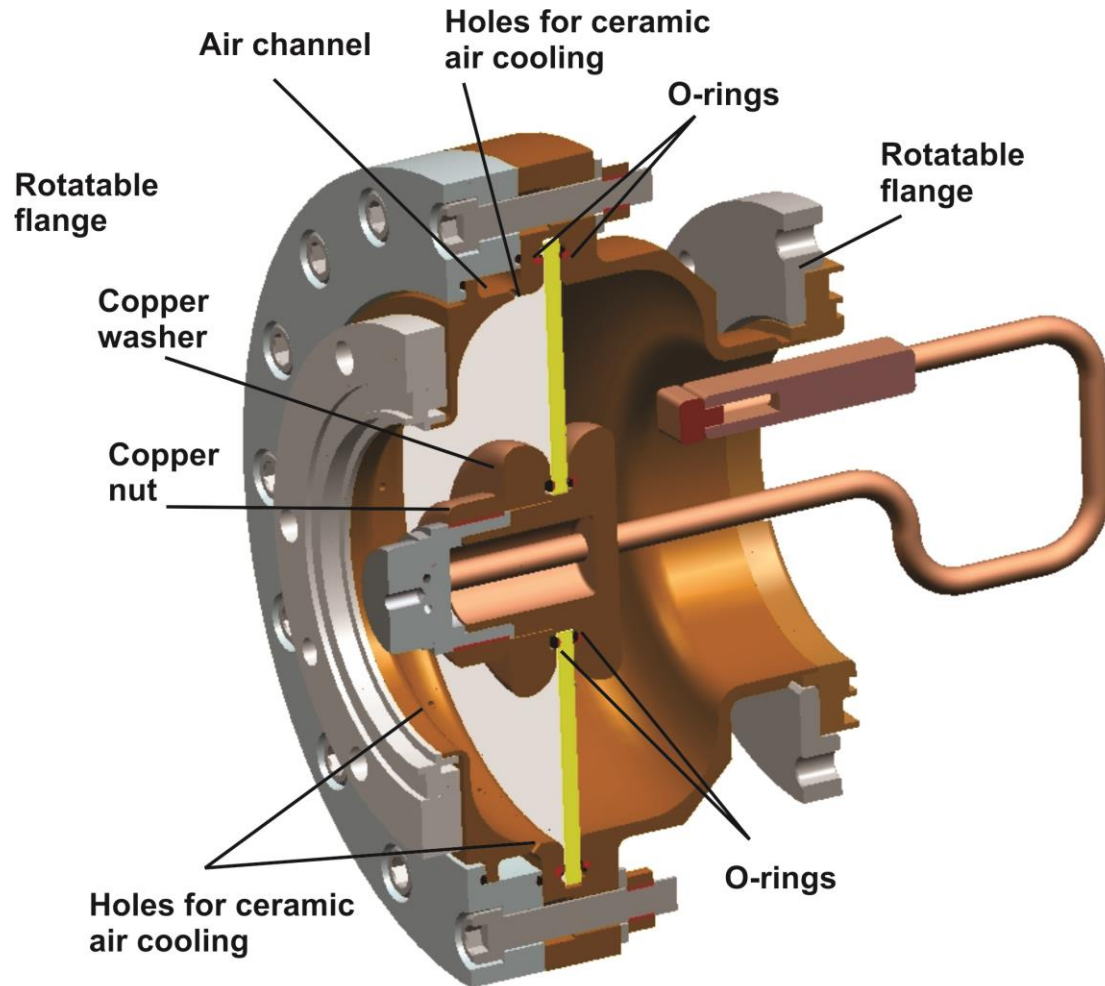
Windows with replaceable ceramic and Viton O-rings were designed.

Size of ceramics: 6" x 4mm.

Ceramic disk is not coated. Multipactor is suppressed by high voltage bias, ~ 4 kV.

Two window units work well without signs of degradation at power levels ~ 60 kW, CW.

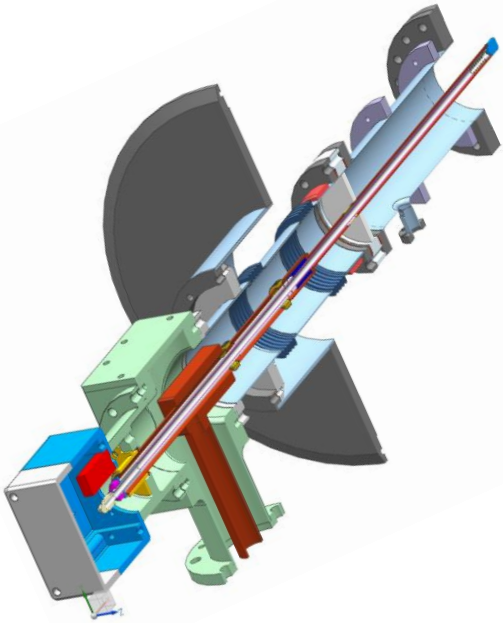
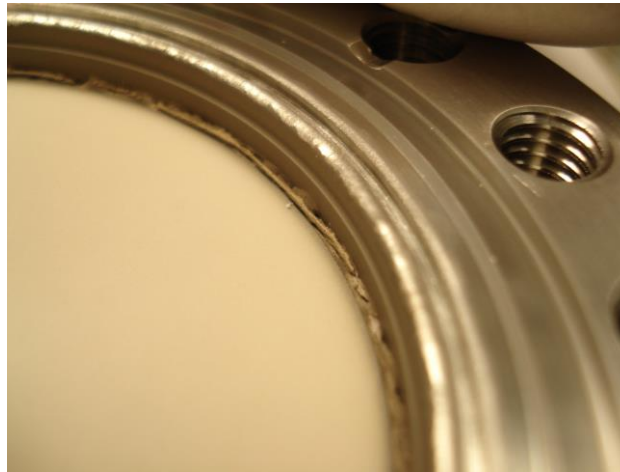
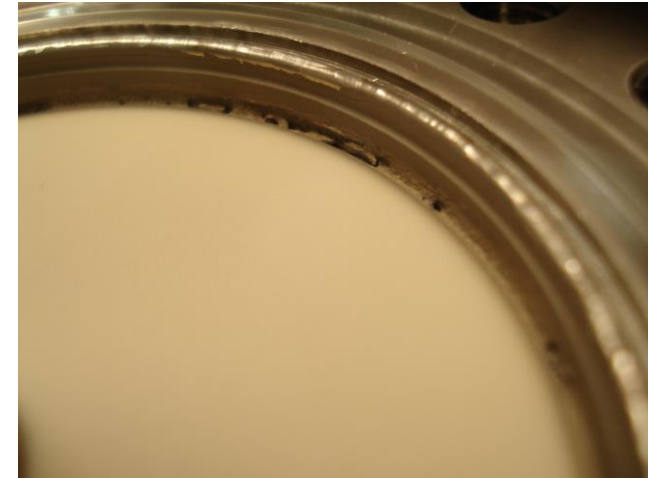
First 3 windows with antenna was produced by “Omley” company. The company specializes in the production of vacuum ceramic products. Despite this the quality of brazing was rather poor: windows were vacuum tight but brazing materials can be pilled off. Nevertheless two couplers were tested successfully up to 30 kW, CW, full reflection. Third window was successfully tested with SSR1 cavity.

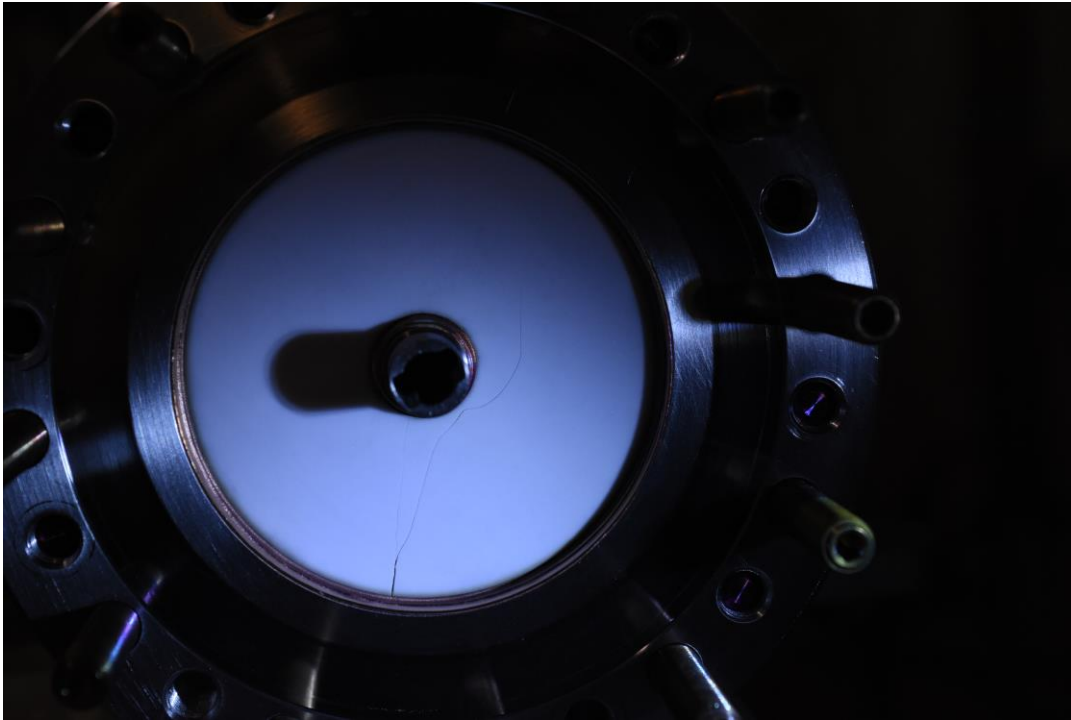
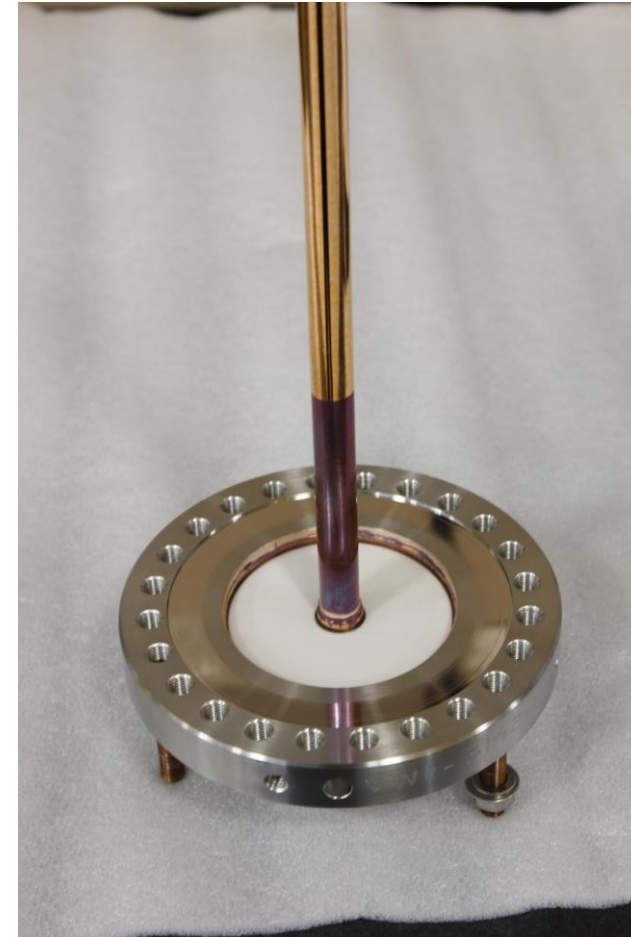
Three of first CPI coupler were produced with not so good ceramic to save time (We were late ~ 2 years). One of window was broken at 20 kW full reflection.

Broken window from CPI.

Vacuum part of antenna was oxidized (after crack). It means the temperature was rather high (~ 200 C ?).

I could not get this temperature in simulation with measured loss tangent (at 100C). Maybe the ceramics was even worse than we think.
